REHABILITATION OF NAVIGATION LOCK WALLS: CASE HISTORIES

James E. McDonald

Structural Laboratory

December 1987

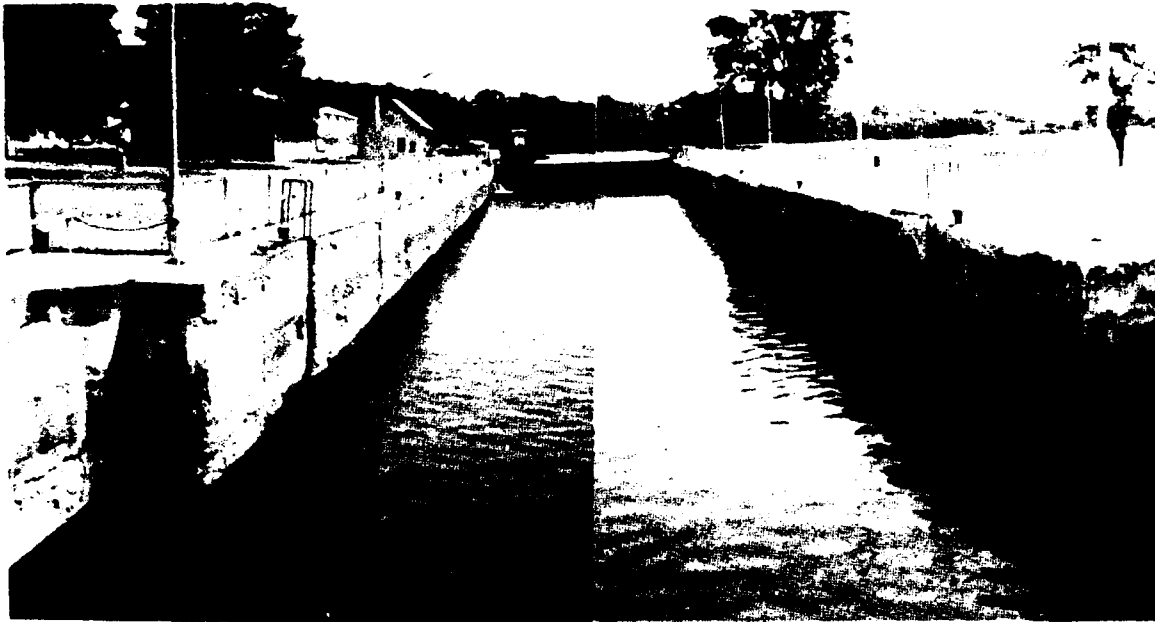
49. After 55 years exposure to the elements, lock concrete surfaces were severely scaled (Figures 17 and 18). An investigation was initiated in 1977 to determine the extent and causes of the concrete deterioration. Two 6-in.-diam holes were core drilled vertically through the landside lock wall and 5 ft into the underlying bedrock. In addition, 6-in.-diam cores were obtained from a total of 12 horizontal and vertical holes drilled to depths of

Figure 17. General view of lock looking upstream 1977,
Old Lock No. 14, Mississippi River

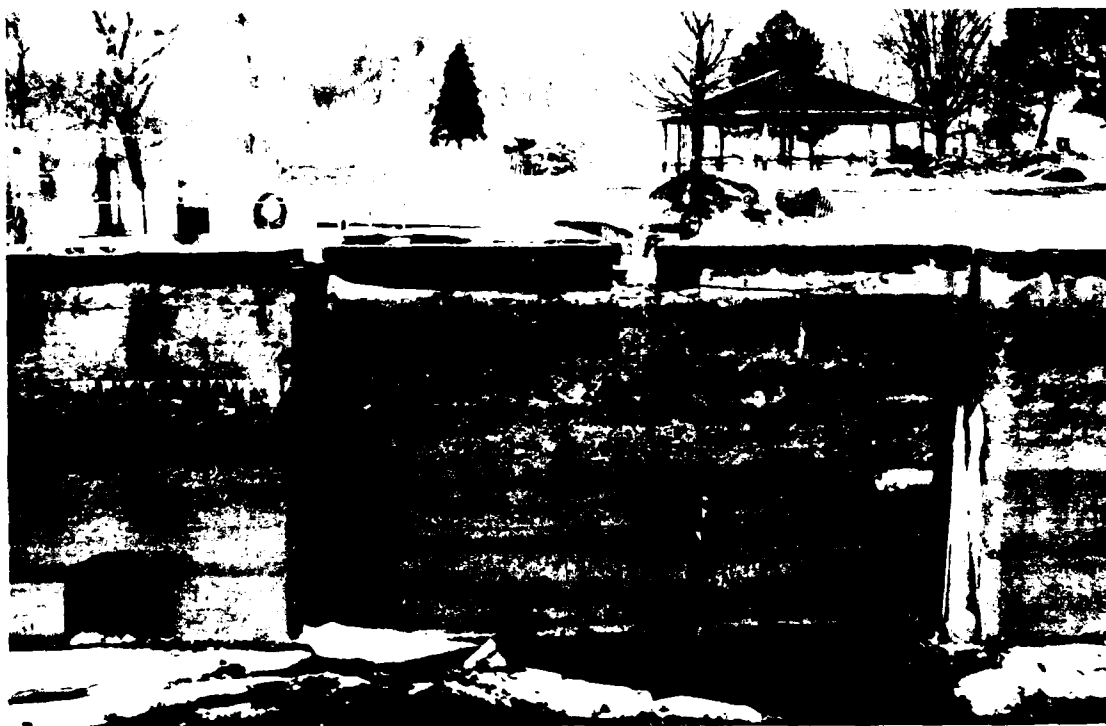
Figure 20. Typical concrete deterioration, February 1980, Old Lock No. 14, Mississippi River

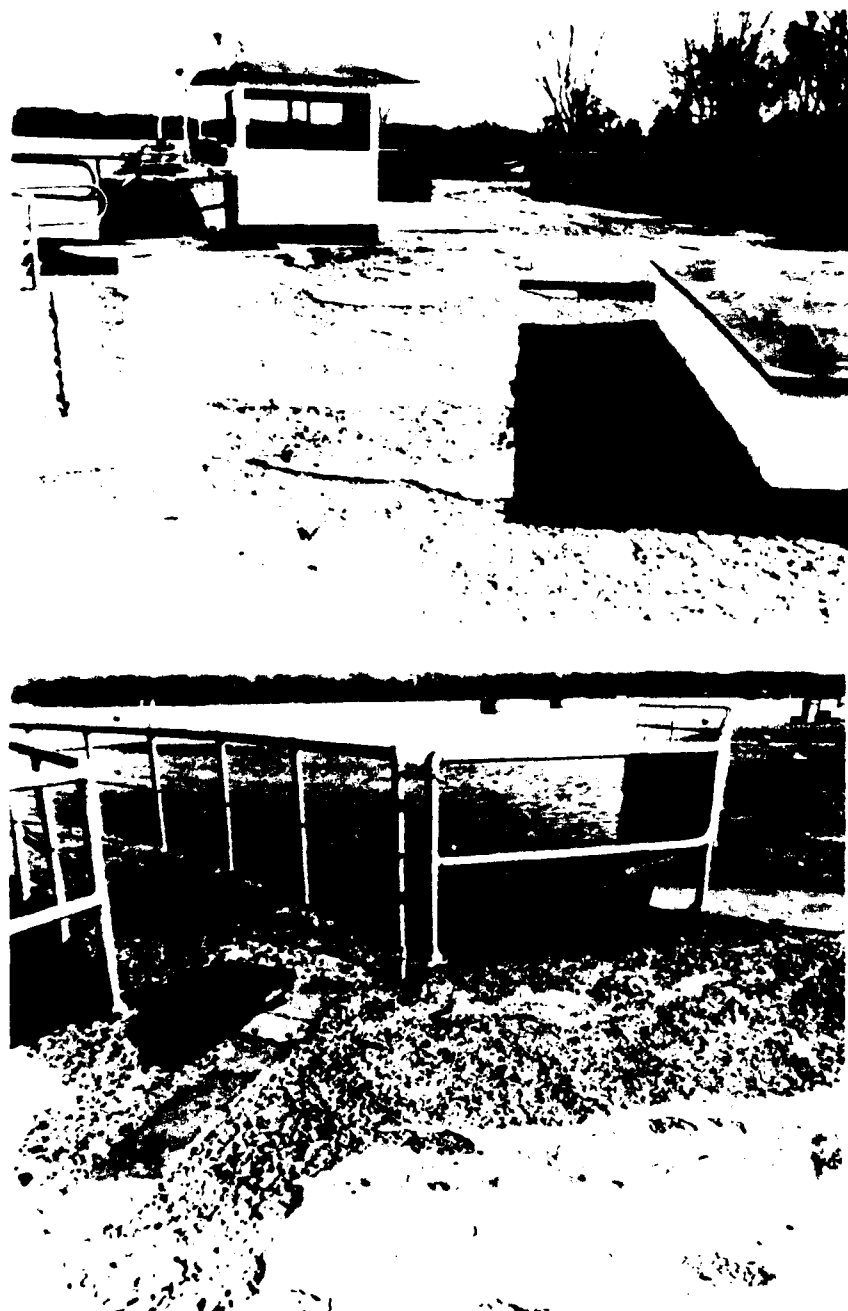
Figure 29. Typical concrete deterioration on tops of lock walls, 1961, Dresden Island Lock and Dam

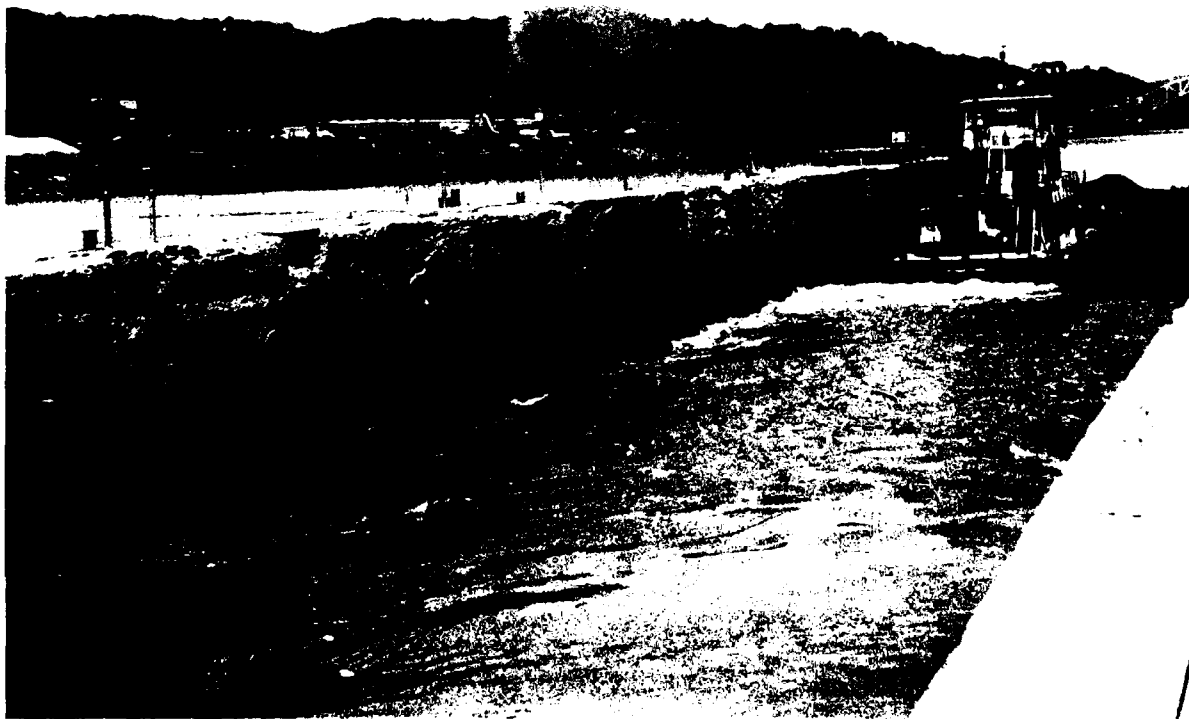
96. From general observations, it was noted that the lock walls were badly spalled and scoured. Previous shotcrete repairs of the wall faces were almost completely deteriorated (Figure 47). The structural beams supporting

Figure 47. Concrete deterioration in river chamber, June 1978,
Lock No. 3, Monongahela River

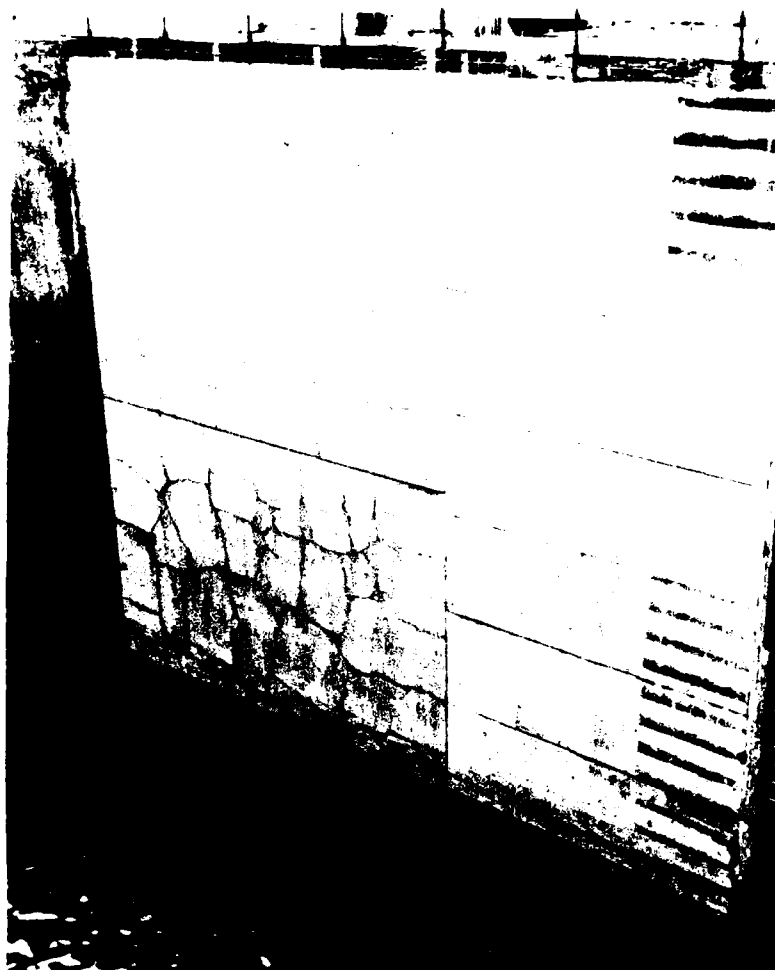
Figure 107. Concrete cracking in a resurfaced monolith (left) compared to reconstructed monolith, Lock No. 1, Mississippi River
